Successful Single Trip Recovery Using Parker's 26" Open Hole Fishing and 20" Casing Tools on a Deepwater Rig

Exploratory Well | Andaman Offshore | India

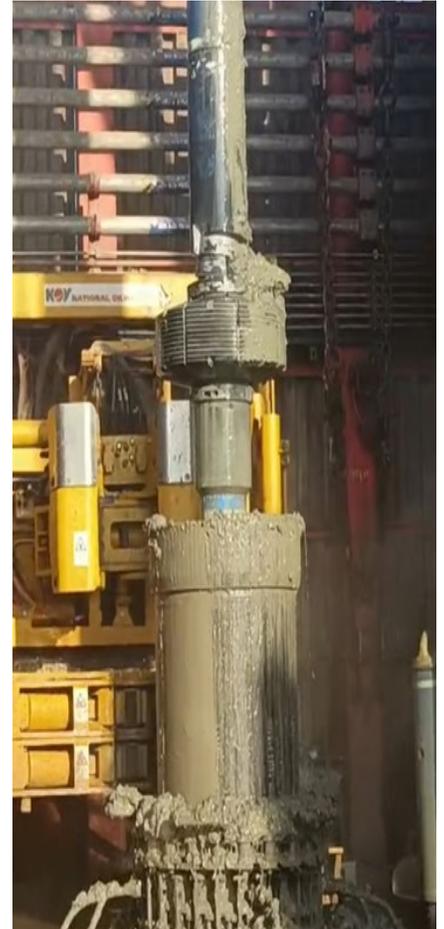
213m length – 20" CSG #133 ppf. | CSG wt - ~78 Klbs (buyont)
TOF – 395.5m, 20" CSG box connection.

- The BHA tools were designed according to the job requirements and deployed.
- A Spear BHA with an 8 1/2" taper mill at the bottom, guided by a 12 1/4" stab and a 17 1/2" stab was utilized to swallow the TOF.
- This setup was designed to center the casing position, making it easier for the spear grapple to swallow the TOF.

- The 8 1/4" Bowen Itco releasing spear and the 20" CSG spear grapple with NC18.730" applications were used for the operation.
